**MC(11)04**

## **MAIB SAFETY BULLETIN - COLLAPSE OF PASSENGER WALKWAY DUE TO UNINTENDED ENGINE MOVEMENT IN PORT**

### ***BEN-MY-CHREE*: COLLAPSE OF THE PASSENGER WALKWAY DUE TO UNINTENDED ENGINE MOVEMENT IN PORT**

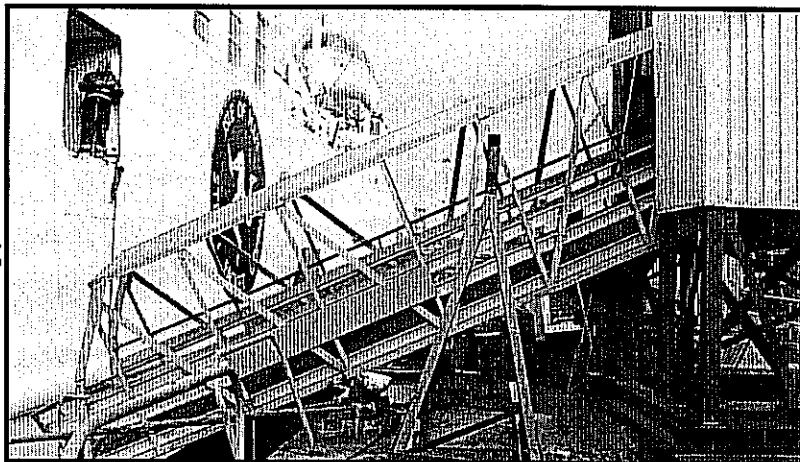
The third engineer, who had previously been concentrating on bunkering, transferred controls to the bridge, and the chief officer, not observing that the starboard engine was running, put both engines' pitch control levers to the full ahead position. Within a few seconds, the vessel surged ahead, causing serious damage to the passenger access structure. The foot-passenger walkway detached at both ends and collapsed onto the quayside, and the gangway fell from the vessel's side shell door and was left hanging on a single rope. Fortunately, there were no injuries. Eight passengers were trapped in the gangway compartment of the shore structure and had to be rescued by the fire service.

The Health & Safety Executive (HSE) completed an investigation into the failure of the passenger access structure. The investigation identified that the quay on which the passenger access structure was built had suffered considerable settlement over the years; the walkway was secured to the rest of the structure with only two small bolts at either end; and there were no records of inspections or maintenance

work having been carried out on the structure. The HSE issued several recommendations to Heysham Port, which are relevant to all passenger terminals. These include:

- *An inspection regime, similar to that for bridges, should be adopted with the findings of the inspection recorded and any remedial work identified should be carried out within an appropriate timescale. Particular attention should be given to safety critical parts of the structure. The inspection should be carried out by a competent person.*
- *For the procurement, operation and maintenance of ship to shore structures, reference should be made to the guidance provided in CIRIA Report C518, Safety in Ports, ship to shore linkspans and walkways.*
