## **MAIB SAFETY BULLETIN – CAPACITOR FAILURE/EXPLOSION**

**MAIB SAFETY BULLETIN 4/2010**

Catastrophic failure of a capacitor and explosion in an 11kV harmonic filter  
on board the passenger cruise vessel RMS *Queen Mary 2*

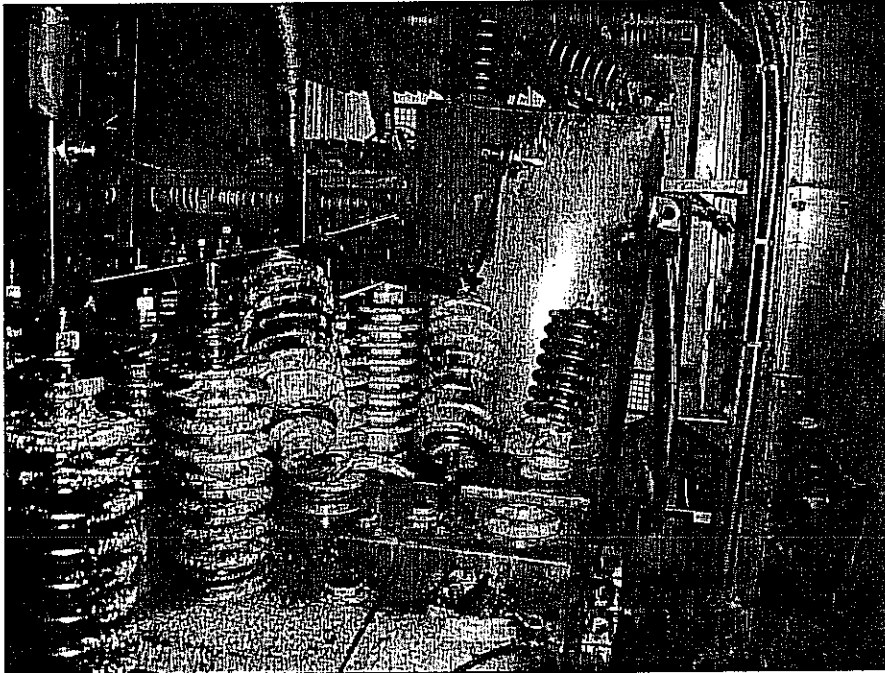
Figure 1

At 0426 (UTC+1) on 23 September 2010, the cruise liner RMS *Queen Mary 2* was approaching Barcelona when one of 12 capacitors in a harmonic filter<sup>1</sup> failed (**Figure 1**), accompanied by a loud explosion. The explosion resulted in extensive damage to the surrounding electric panels and caused the vessel to black out. There were no navigational hazards nearby, main power was restored at 0455 and the ship was able to get back underway at 0523.

Capacitor which failed causing it to rip off the foundation bolts and rise approximately 60cm

Preliminary findings of the investigation carried out by the manufacturer of the capacitor indicate that the capacitor had deteriorated gradually. The monitoring device based on current unbalance detection did not give any indication of the fault developing. The dielectric oil appeared to have vaporised due to internal short circuiting, causing internal pressure to build up and resulting in the oil leaking out and being sprayed onto the high voltage bus bars. The oil vapour is likely to have provided a conducting path between the live phases of the 11kV terminals, resulting in a major arc flash event.

S2010/139 Operators of vessels with electric propulsion which have large capacitors in harmonic filters, should urgently:

- Inspect the capacitors and check for any physical distortion, unusual smells (indicating dielectric fluid leakage) and signs of external overheating.
- Ensure that the cooling and ventilation systems are functioning correctly.
- Calibrate and function test any fault detection or condition monitoring system fitted.
- Ensure that if there is a history of capacitors in the equipment needing to be replaced, the underlying causes are understood.
- Carry out a thorough check for the cleanliness of all exposed conductors as well as for external signs of chaffing damage on high voltage cables.

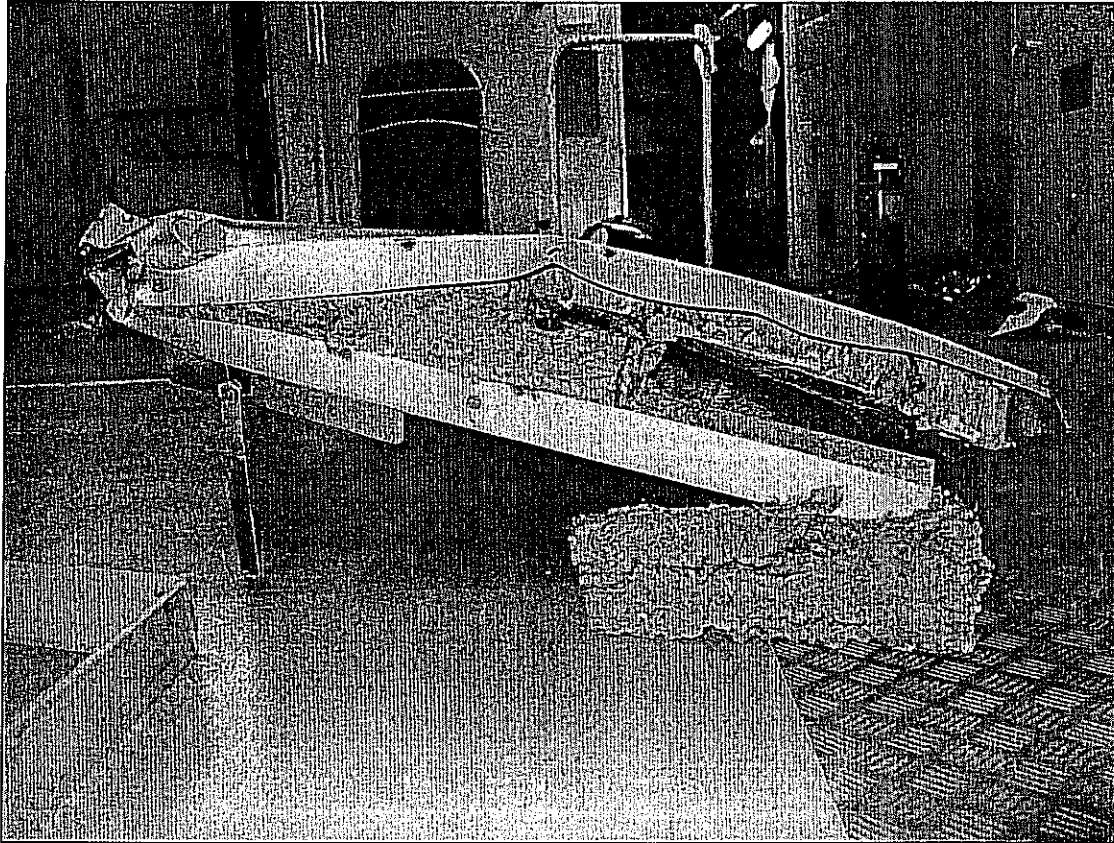
Figure 2

The harmonic filter was connected directly to 11kV bus bars and was located in a compartment within the aft main switchboard room. The blast forced the steel door to the compartment out through its frame and also caused serious damage to an adjoining steel door into the main switchboard room (**Figure 2**). The stiffeners on the bulkhead of the compartment were buckled and the steel cover plate on a cross-flooding duct was blown out into the main switchboard room. Fortunately there were no personnel in the vicinity. The steel casing of another capacitor in the same group was found to have bulged severely and was possibly on the verge of failure (**Figure 3**).

Damaged steel door to the harmonic filter compartment

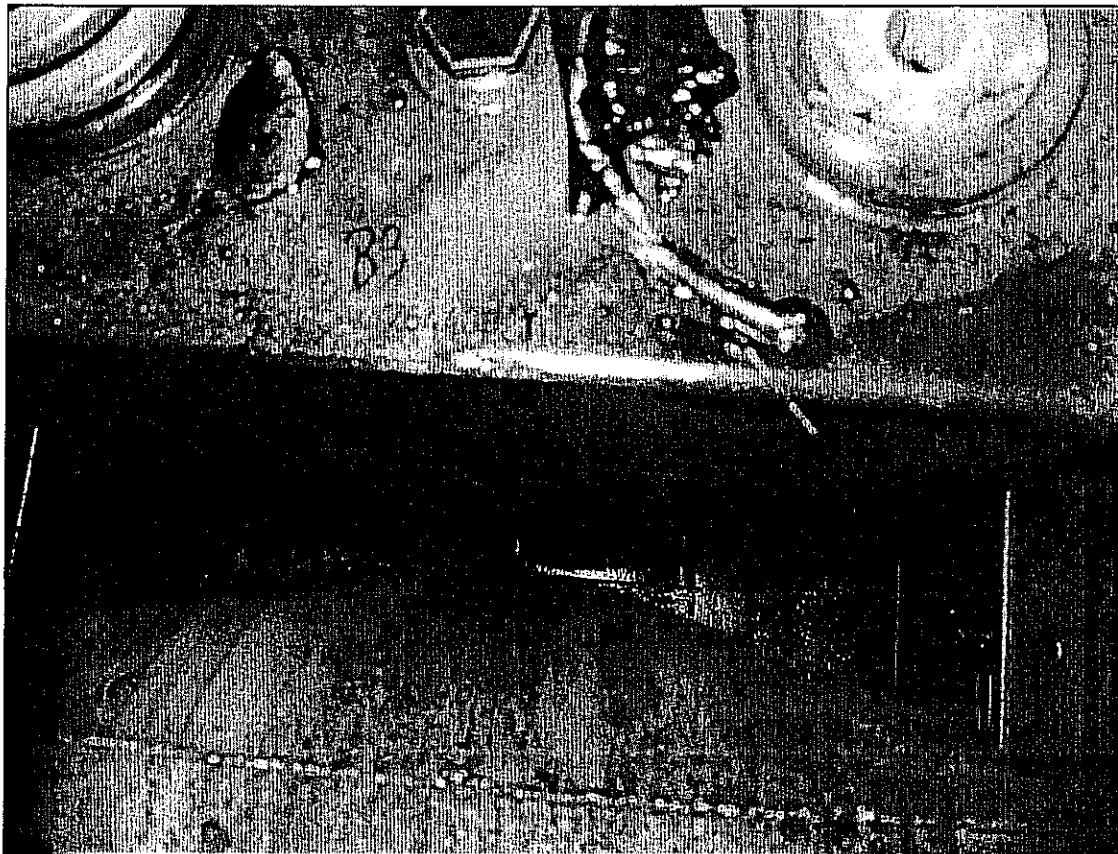
Figure 3

Top view of two capacitors indicating one which had developed a severe bulge due to internal pressurisation

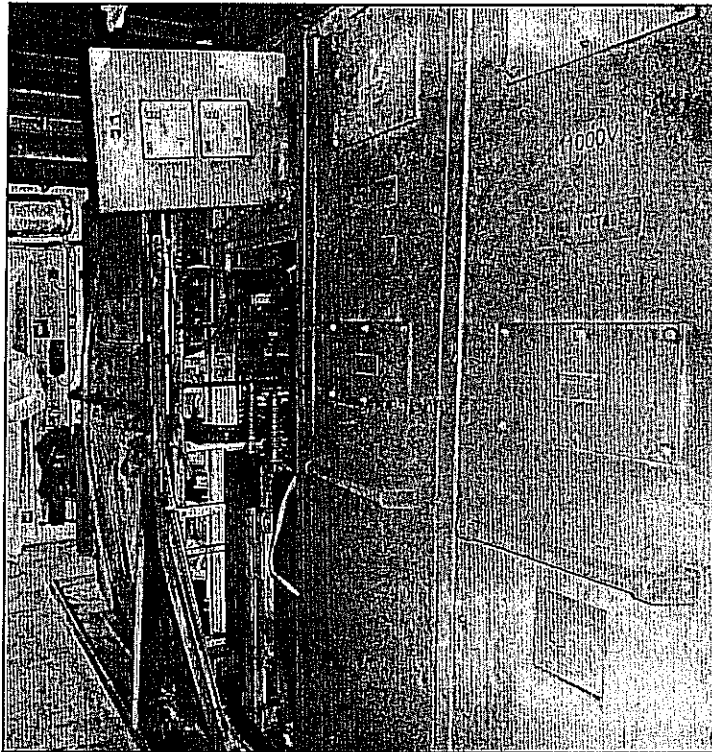
Figure 4

There was evidence of smoke and heat in the compartment (**Figure 4**), and any fire was probably extinguished by water from the hi-fog system. Two hi-fog outlets, one in the harmonic filter compartment and the other in the main switchboard room, were activated in the wake of the blast.

Soot staining on the blown-out doors of the harmonic filter casing
